REFURBISHING/REPAIR

HOMOGENIZER APV GAULIN MODEL M6

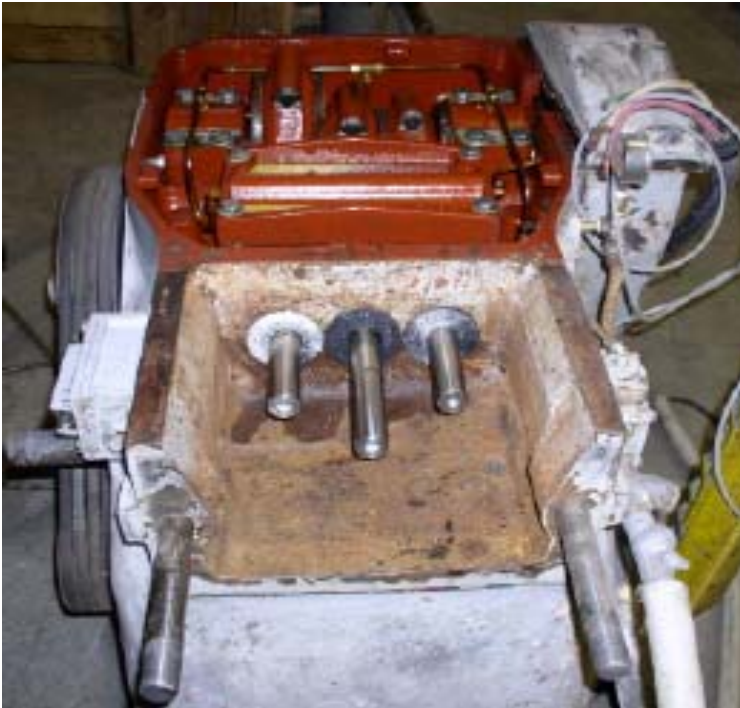
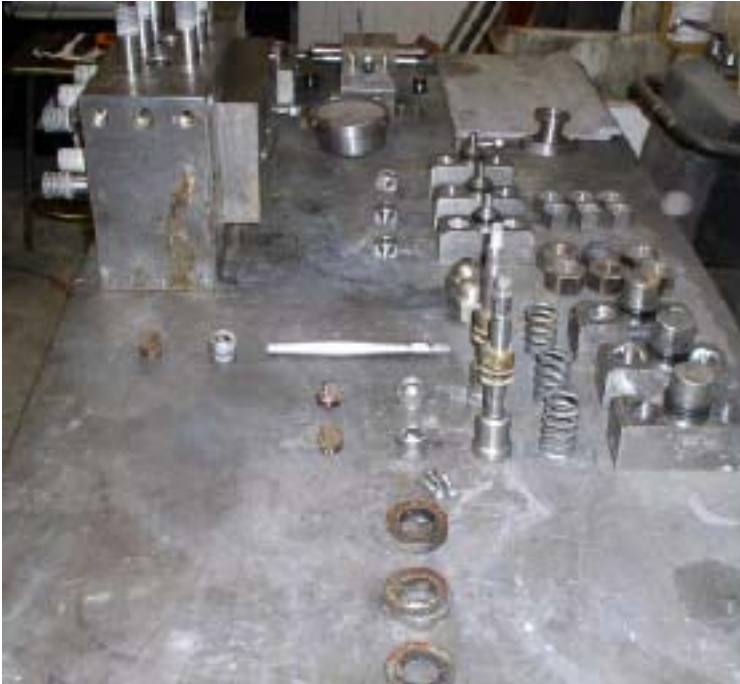
The tapered valve seat cylinder, the two stage homogenizing valve assembly and the single stage homogenizing valve assembly with 49, 32 and 16 individual parts were stuck in place with little movement caused by oxidized parts and misalignment. High value valve seats, impact rings, valve packing needed to be removed with hydraulic pressure in excess of 50 tons and replaced.

The unit was completely disassembled to expose all drive components, such as valve seat cylinder, 2-stage valve assembly, hydraulic valve actuator, motor, belts, pulleys, bushings, bearings, fasteners, piping, etc.

All machined parts were re-machined and polished to original conditions and tolerances.

All non machined parts like bearings, bushings, seals, belts, motor were replaced to original specifications.

All oxidized parts including pump, hydraulic relief valve, lubrication and cooling water tubing were reworked or replaced.

The base and drive components, about 137 individual parts, were reworked to operating conditions.

These components and parts had to be disassembled, inspected, reworked and reassembled. New oil, strainer and belts were installed
