## **REFURBISHING/REPAIR**

### **HORIZONTAL SHOT MILL**

#### **CHAMBER AND HEAD REWORKED**

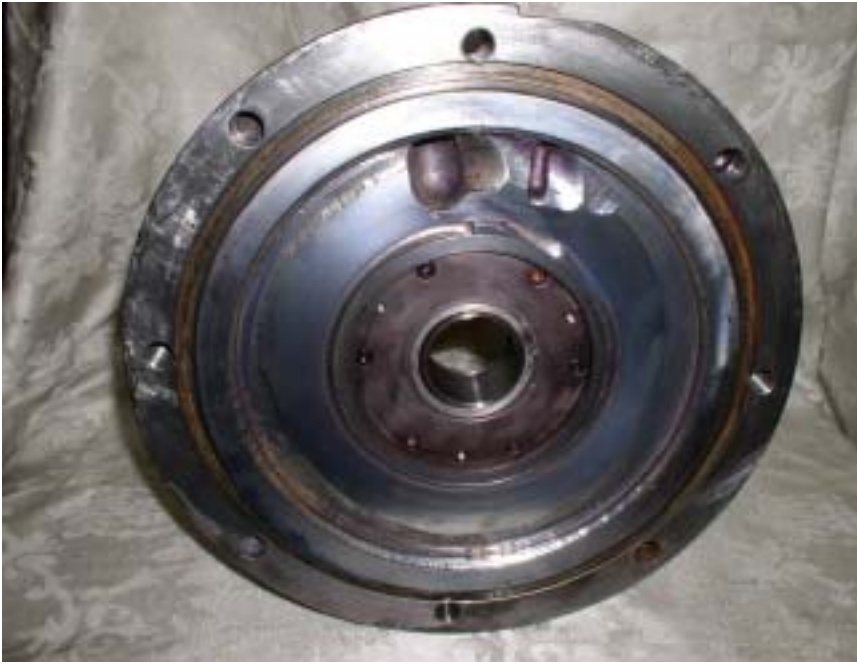
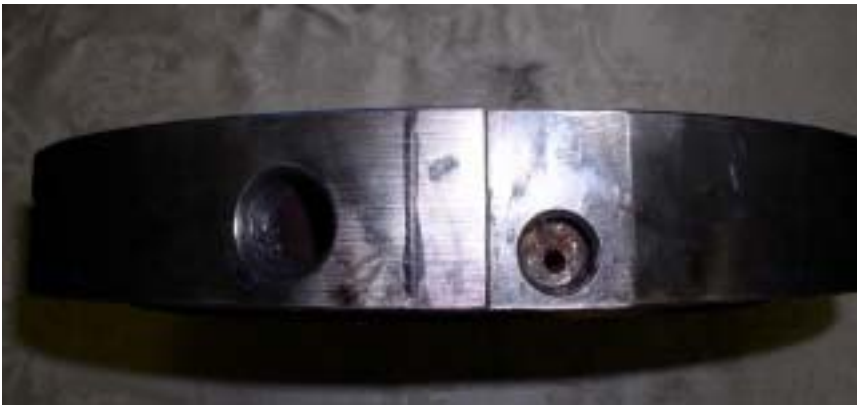
The unit was disassembled at site and trucked to shop for re-inspection and refurbishing.

The chamber head had to be pressure tested for leaks, build up the corroded spots with welds, re-machine to original tolerances and re-test for leaks.

The internal openings had to be cleaned and tested for corrosion and wear,

The chamber flanges had to be cleaned and re-machined to original tolerances.

The jacketed chamber had to be leak tested under pressure and re-welded where leaks appeared. Internal welds had to be ground smooth.

The chamber had to be mounted to the head with seal in place, realigned and torque the high strength fasteners.

The rotating mixing shaft assembly with the inspected disks in place was inserted into the chamber with seal in place and the high strength fasteners inserted with proper torque.
