REFURBISHING/REPAIR

HOMOGENIZER APV GAULIN MODEL M6

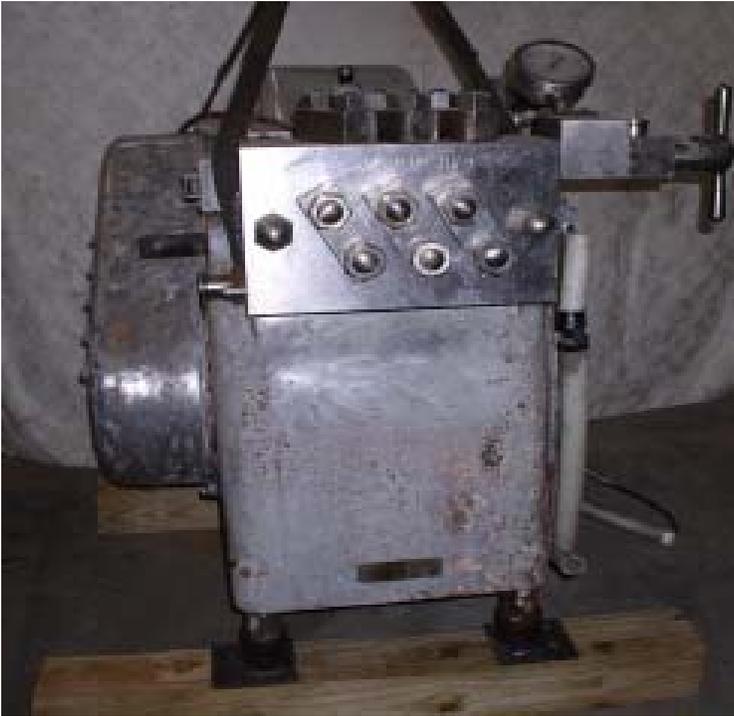
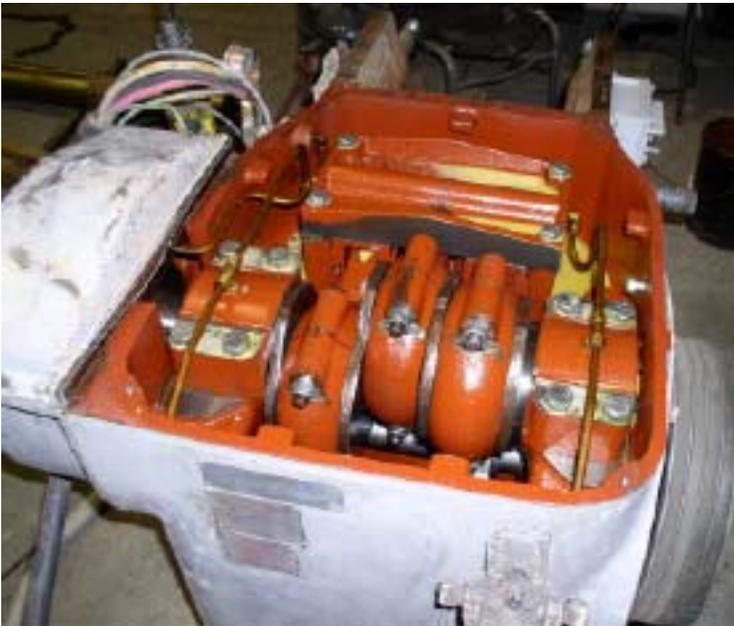
The tapered valve seat cylinder, the two stage homogenizing valve assembly and the single stage homogenizing valve assembly with 49, 32 and 16 individual parts were stuck in place with little movement caused by oxidized parts and misalignment. High value valve seats, impact rings, valve packing needed to be removed with hydraulic pressure in excess of 50 tons and replaced.

The unit was completely disassembled to expose all drive components, such as valve seat cylinder, 2-stage valve assembly, hydraulic valve actuator, motor, belts, pulleys, bushings, bearings, fasteners, piping, etc.

All machined parts were re-machined and polished to original conditions and tolerances.

All non machined parts like bearings, bushings, seals, belts, motor were replaced to original specifications.

All oxidized parts including pump, hydraulic relief valve, lubrication and cooling water tubing were reworked or replaced.

The base and drive components, about 137 individual parts, were reworked to operating conditions.

These components and parts had to be disassembled, inspected, reworked and reassembled. New oil, strainer and belts were installed.
